Manhole Inspection Summary

Manhole # S13QQ1001MH

Location Address: **2730 GARRISON AVE**

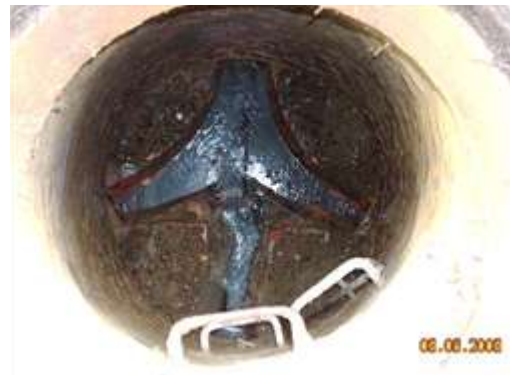
Top View

Corroded steps. Evidence of surcharge - Bench debris. Channel debris.

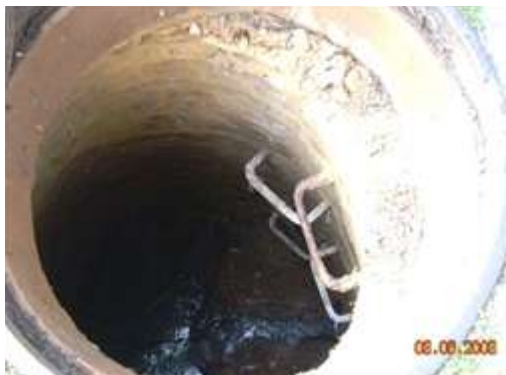
Defect

Frame leaks. Frame offset. Corbel deterioration and infiltration. Barrel infiltration.

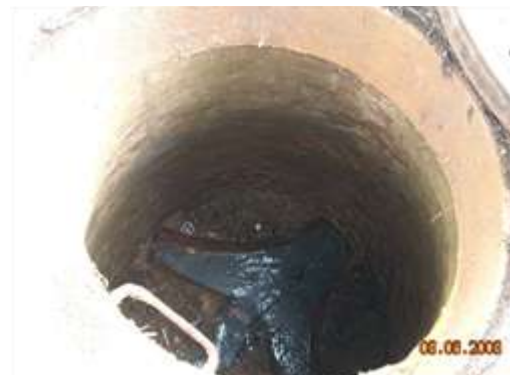
Defect

Frame leaks. Corbel deterioration and infiltration. Barrel infiltration.

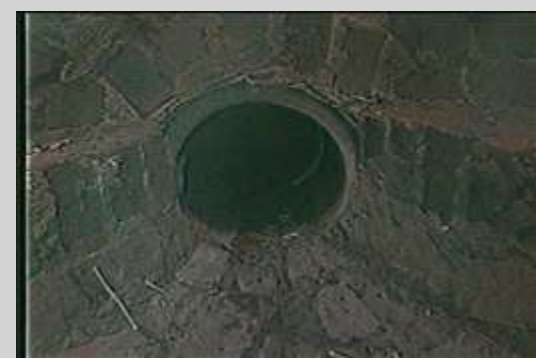
8 in. Circular Gravity Sewer Pipe Out @ 12 O'Clock

Infiltration: **Evidence** Pipe Seal Cond: **Unknown**

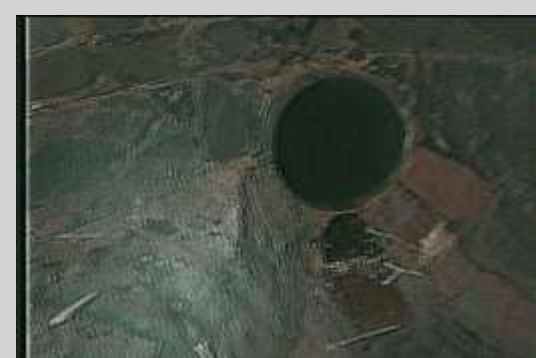
6 in. Circular Gravity Sewer Pipe In @ 3 O'Clock

Infiltration: **Evidence** Pipe Seal Cond: **Cracked**

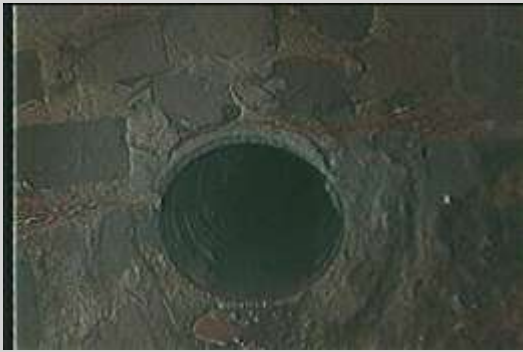
Pipe In @ 6 O'Clock

Infiltration: **Evidence** Pipe Seal Cond: **Cracked**

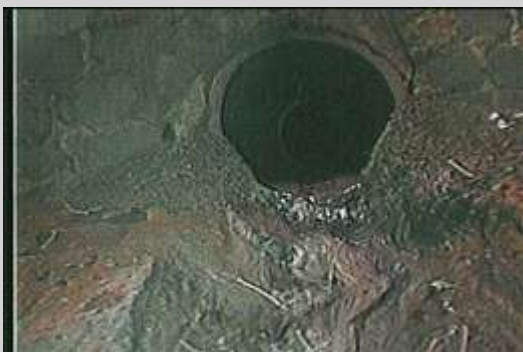
Pipe In @ 8 O'Clock

Barrel deterioration and infiltration. Channel deterioration and root intrusion.

Infiltration: **Evidence** Pipe Seal Cond: **Roots**
